**ENFIELD RIFLES: THE COMPOSITE CONSERVATION OF OUR
AMERICAN CIVIL WAR HERITAGE**

A Thesis

Submitted to the Office of Graduate Studies of
Texas A&M University
in partial fulfillment of the requirements for the degree of

December 2008

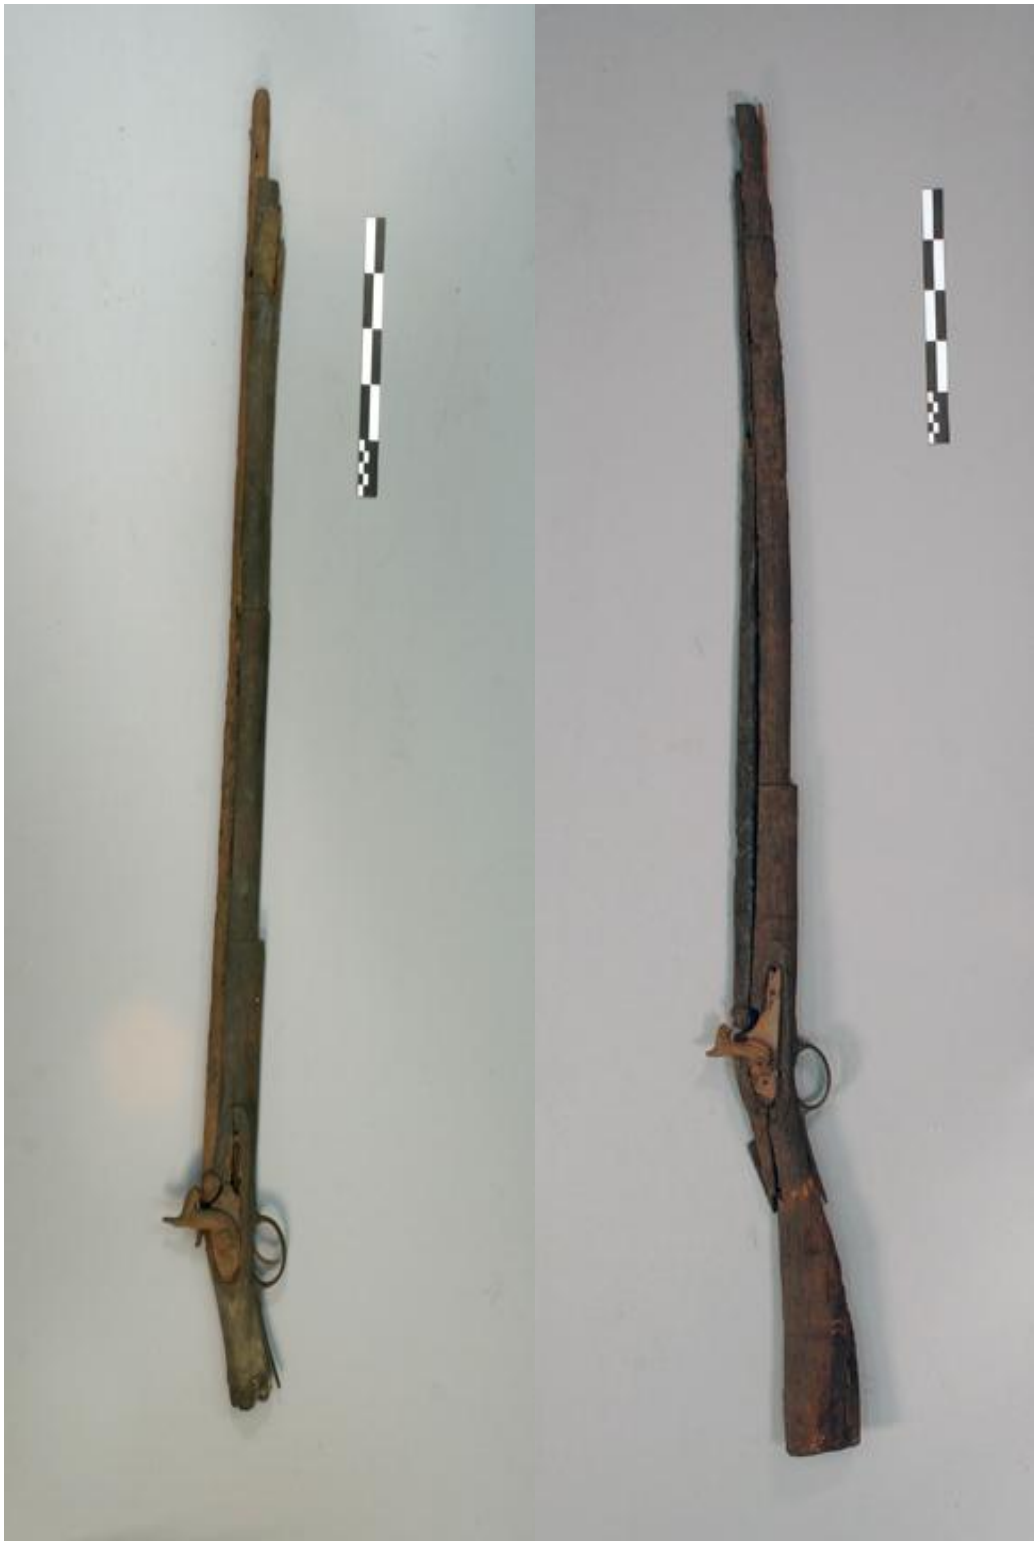
Artifact MGR-001 (previously MG-A-6) was conserved by the tetraethyl orthosilicate (TEOS) process (figure 2). Mechanical cleaning combined with chemical cleaning took place prior to treatment to expose as much of the original surface as possible. The rifle was assumed to already be desalinated due to the storage technique employed at Fort Fisher, so no further steps were taken to remove salts. The artifact was taken through a series of acetone baths, followed by isopropyl alcohol baths to remove most of the water. However, the goal was not to remove all the water in this process. It is necessary for the TEOS to react with the remaining inter-cellular water to form silicone dioxide. This silicone dioxide is what remains to bulk the fragile wood. Before placing the artifact in the TEOS, three quick treatments of tannic acid were applied to all the visible iron surfaces. The rifle was then allowed to soak for five days in the TEOS, which was deemed a sufficient treatment time. Finally, the brass components were polished, and the rifle was allowed to air dry (Simmons 1979:5-12).

Figure 2. MGR 001(left) and MGR 002 (right) (Photos by R. Sasaki).

Artifacts MGR-002 and MGR-003 (previously MG-A-9) were both treated with the acetone-rosin method, however, isopropyl alcohol was substituted for acetone to prevent dissolving the PVC containers (figures 2 and 3). The difference between the processes of these two artifacts is simply time. MGR-002 was immersed in isopropyl-rosin for only two months, as compared to MGR-003 which stayed in treatment for seven months (D. Hamilton to J. Hawley, letter, 21 March 1983, Conservation Research Laboratory, College Station). Preliminary encrustation removal from the rifles included mechanical and chemical cleaning. The artifacts then underwent several baths of isopropyl alcohol to dehydrate the wood. Following dehydration, tannic acid was applied in three coats to the iron elements, and the brass was polished. Finally, a 66.5 percent solution of pine rosin in isopropyl alcohol was prepared, and the rifles immersed for the previously stated periods (Cassavoy 1979:10-16).

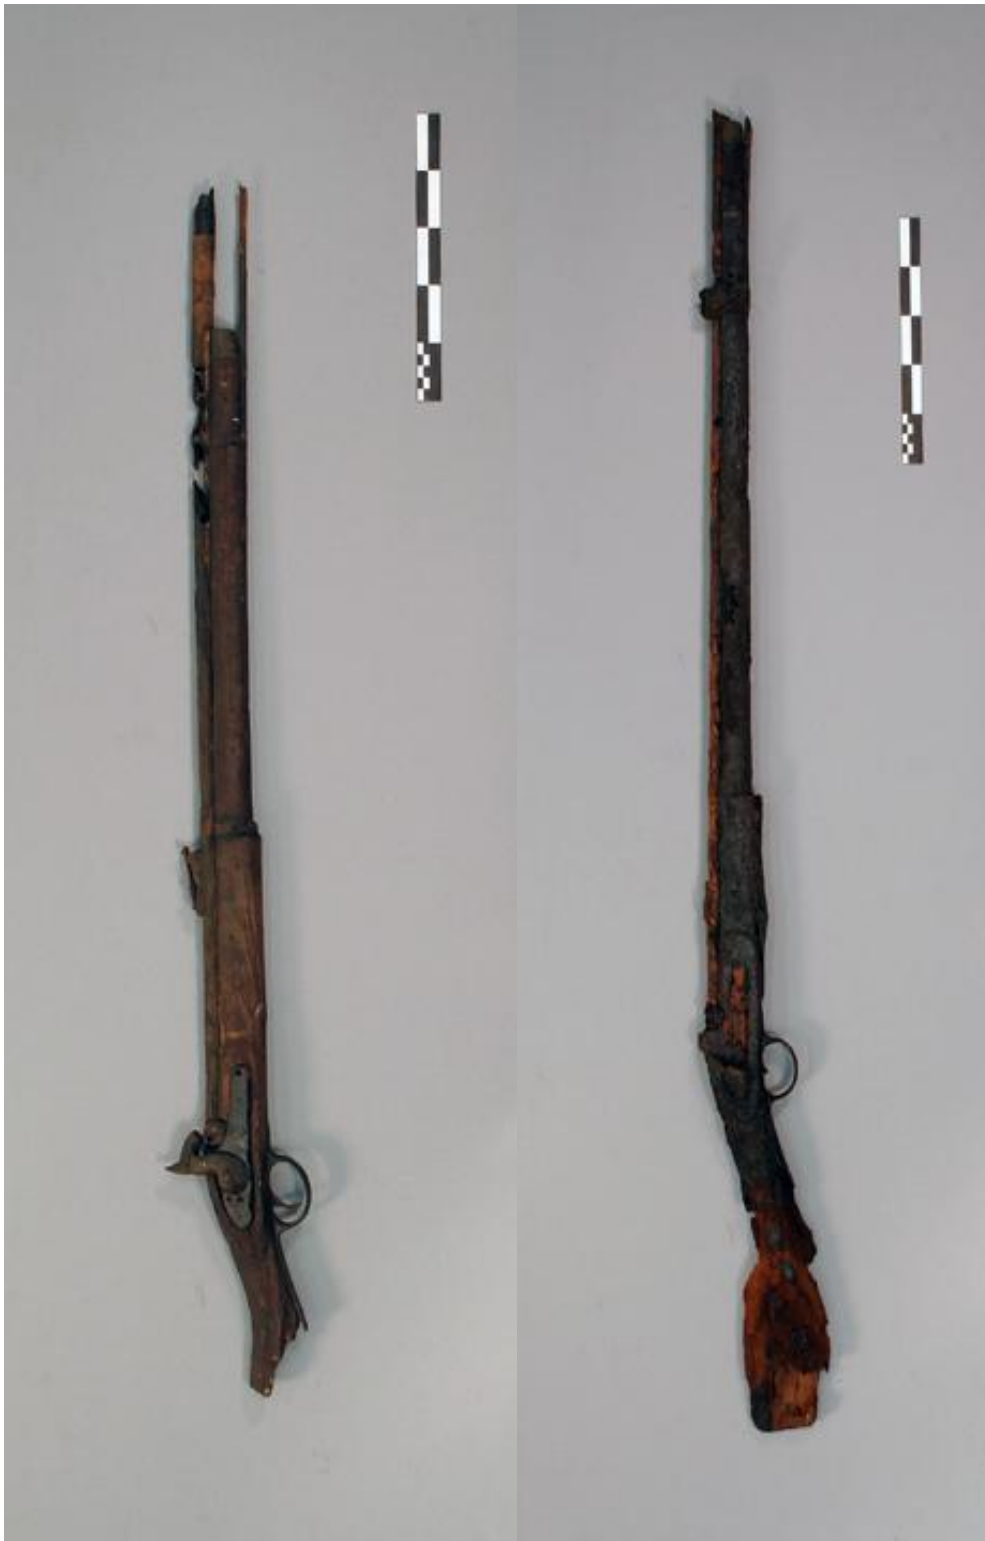
The final rifle, MGR-004, was treated with sucrose (figure 3). Unfortunately, no conservation report survives, but the dark sticky texture of the wood, as well as a smell similar to molasses, make the conservation treatment obvious. Since the particulars of this conservation treatment are not available, the assumption will be made that it proceeded like any other sucrose method, and will not be discussed here.

Figure 3. MGR 003 (left) and MGR 004 (right) (Photos by R. Sasaki).

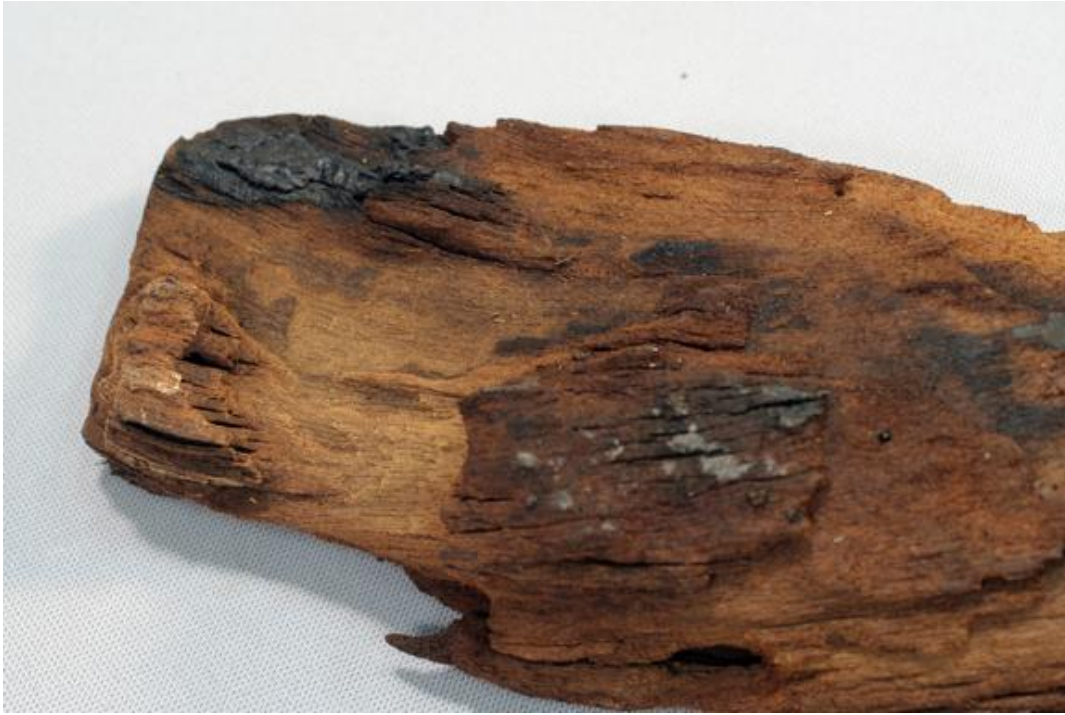
The unsightly sucrose-treated Enfield was attacked and badly eaten by insects, and was eventually sealed in a plastic bag to prevent further attack (figures 4 and 5). The high humidity has leached out a great quantity of the sugar, causing the surface of the gun to be dark, sticky, and moist. The iron has continued to corrode, and if there were any diagnostic marks, they are now gone. The brass appears to be tarnished, but this is easily remedied. In a controlled environment, the wood would probably be in much better condition, however, the iron would still be corroded. This treatment is not suitable for composite artifacts.

Figure 4. MGR 004 butt showing insect attack (Photo by R. Sasaki).

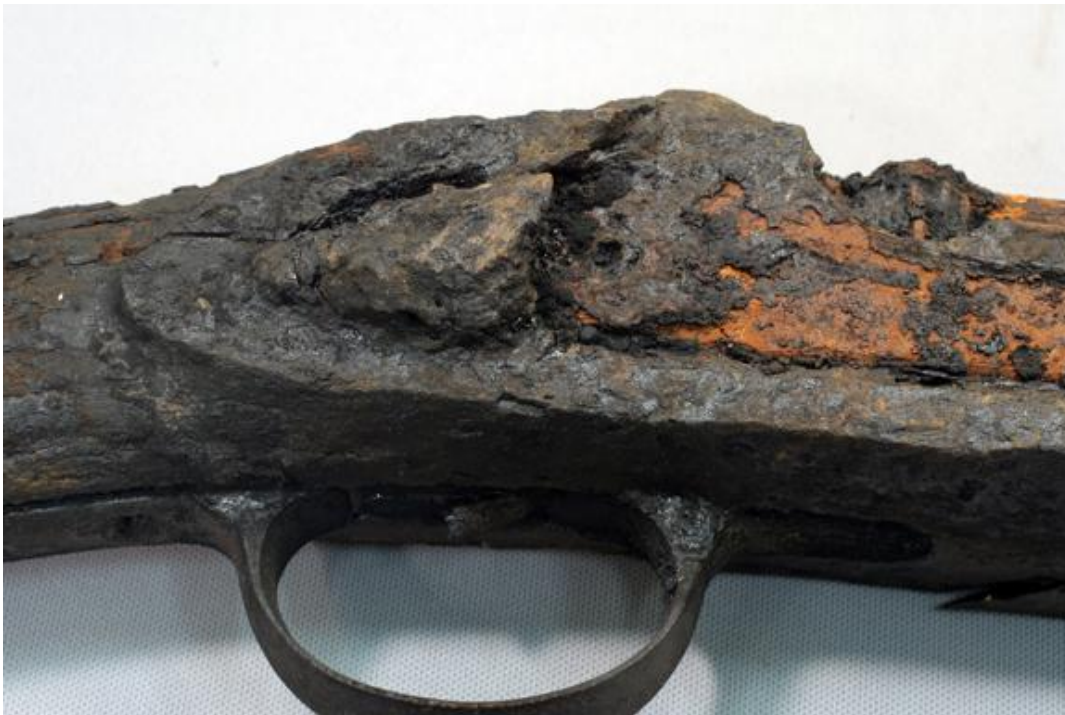
Figure 5. MGR 004 lock (Photo by R. Sasaki).

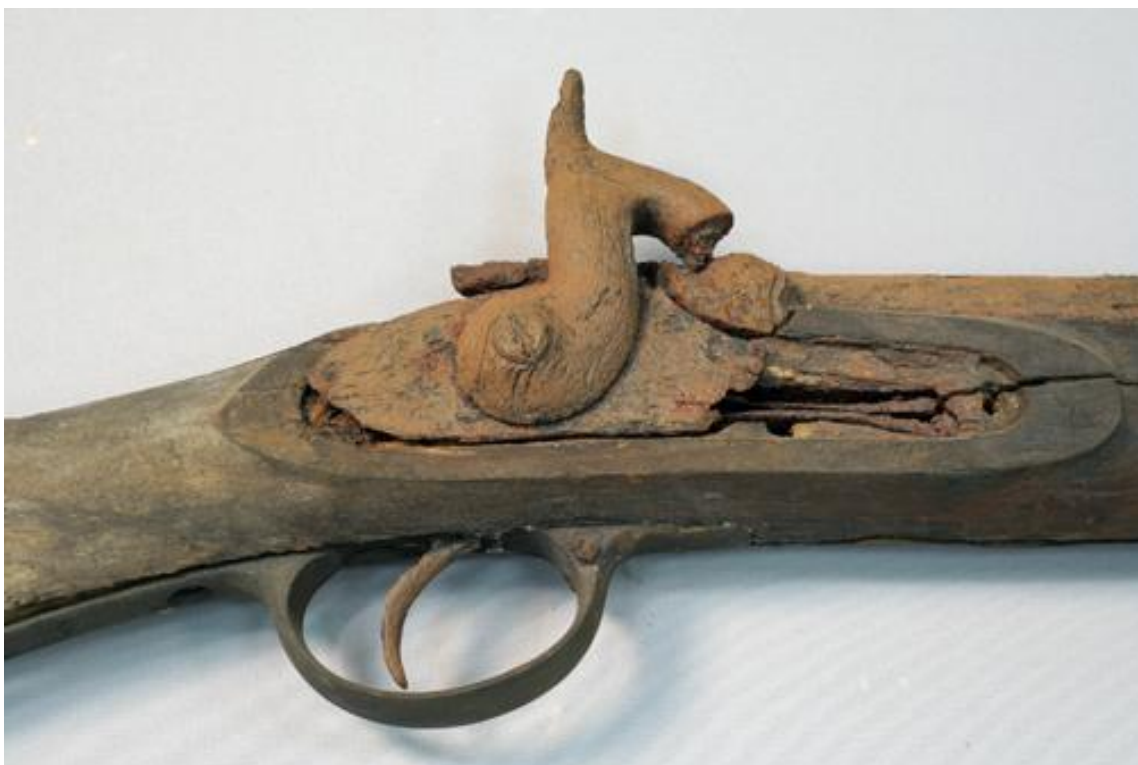
The TEOS treated rifle is in a similar state of decay (figure 6). The wood looks relatively good, but all the iron is badly corroded. The brass appears to be only tarnished, but a white residue around the trigger guard may indicate the presence of bronze disease. This treatment is not acceptable for composite artifacts.

Figure 6. MGR 001 lock (Photo by R. Sasaki).

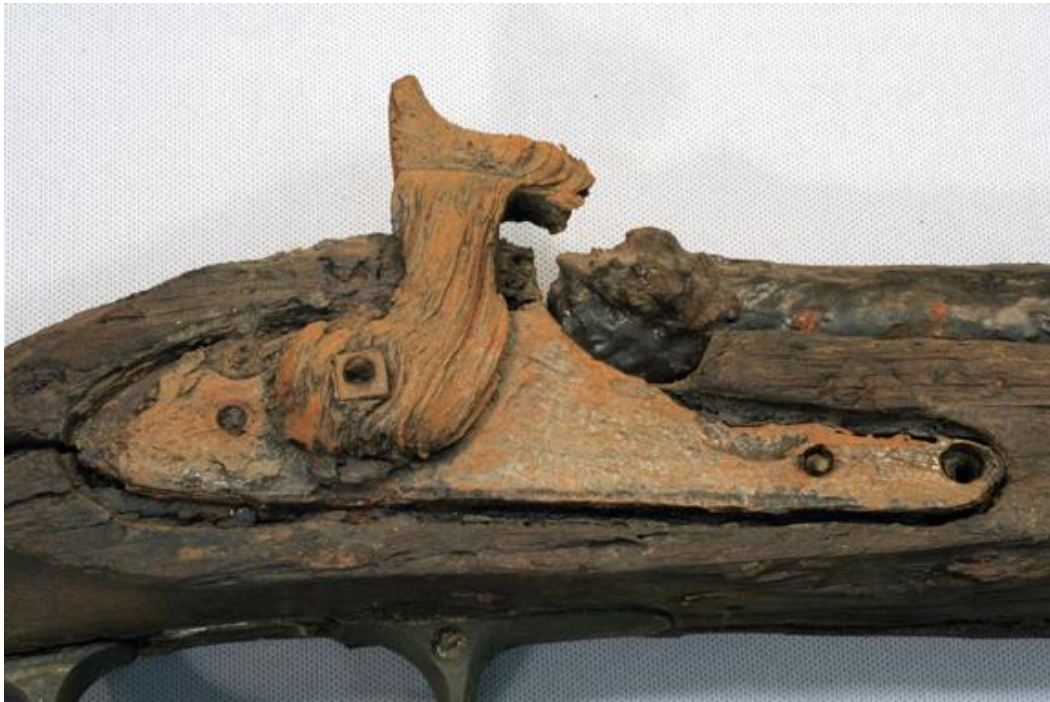
Finally, the isopropyl-rosin treated artifacts are in varying conditions. MGR-002 (2 month immersion) is in a more heavily-deteriorated state than MGR-003 (7 month immersion). MGR-002 is in a similar state to the TEOS treated gun (figure 7). The wood looks relatively good, except for the yellow tint produced by the rosin. The iron is heavily rusted, except the barrel, which apparently separated from the wood post-

treatment and was given an additional coating of tannic acid and wax. The brass has the same tarnished look with the presence of the white residue. MGR-003 is in the best condition of all the rifles (figure 8). There is some rust on the barrel, but generally the iron looks good. The crown, date, and location marks are still visible on the lock plate. The exception to this lies under the lock plate. This iron was not given a tannic acid treatment and is heavily corroded. The brass looks tarnished, but the white residue is absent.

Figure 7. MGR 002 lock (Photo by R. Sasaki).

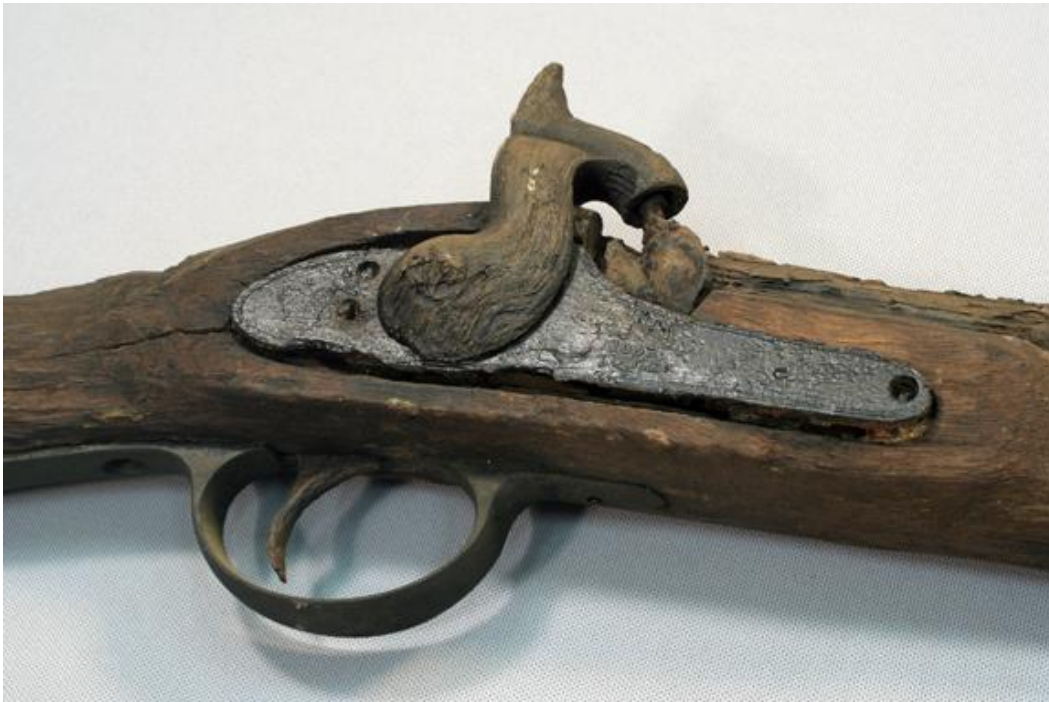
Figure 8. MGR 003 lock with maker's marks (Photo by R. Sasaki).

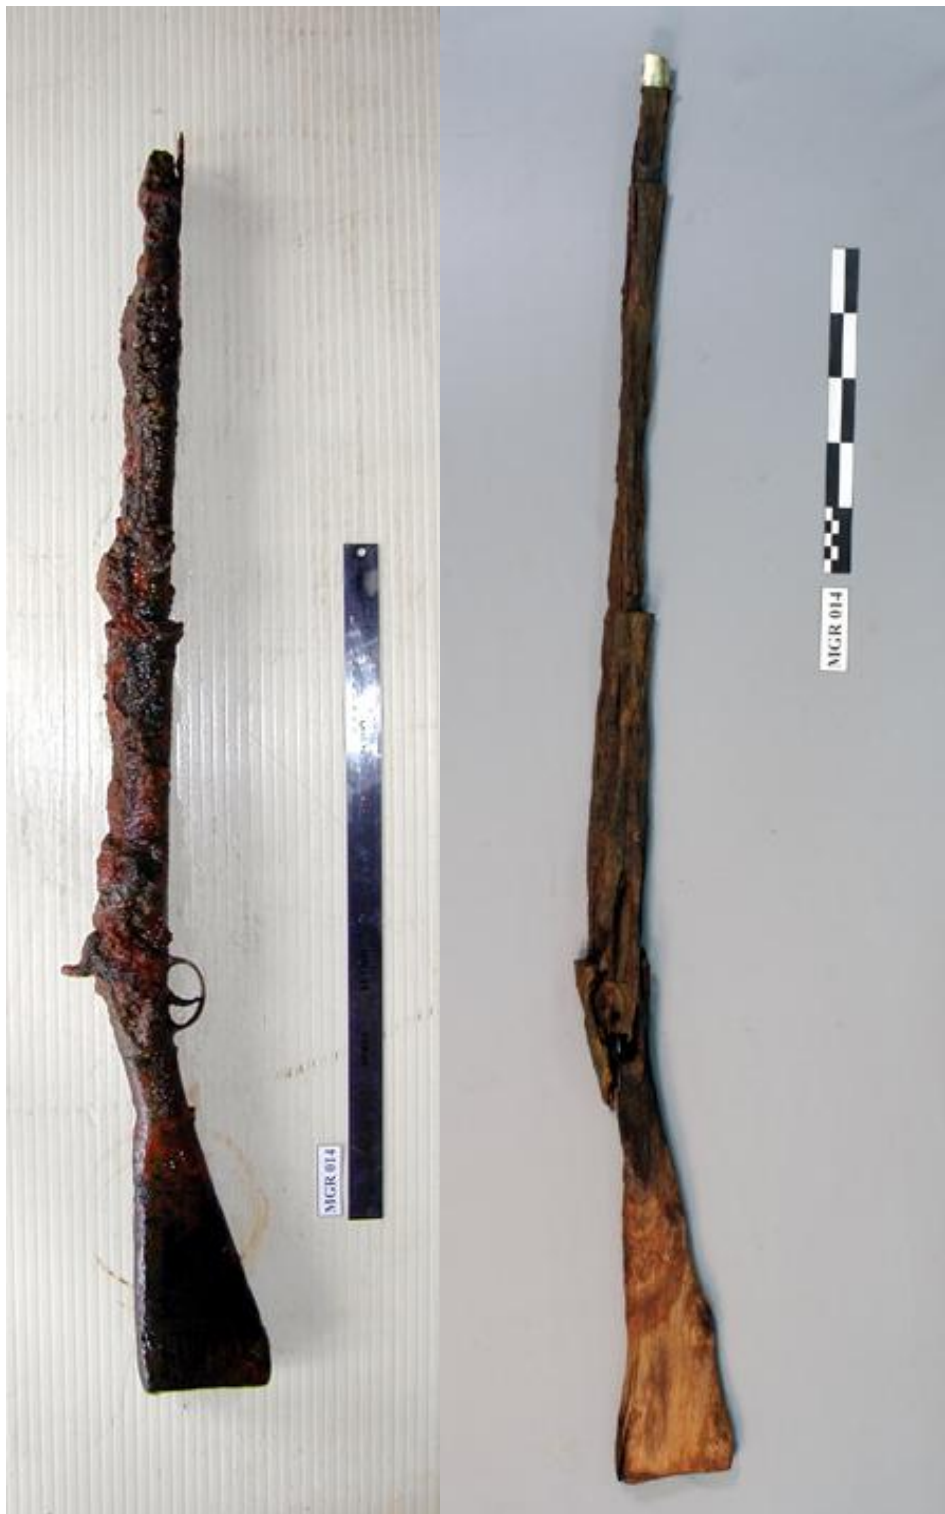
MGR 014 (figure 9) must be discussed first, because the results of the conservation on the wood stock of this rifle changed the conservation procedure for the rest of the rifles. Six months into the ER process, the rifles were mechanically cleaned to expedite the removal of the chlorides. At this time, the butt of the stock broke away from the rest of the gun. It was removed from the electrolyte solution, rinsed, and allowed to air dry while the remainder of the rifle continued through ER. While the wood remained wet, it retained its appearance, but as it began to dry, the wood shrank and warped. This commonly happens to waterlogged wood that has not been treated, indicating that all the silicone bonds created during the silicone oil process had been severed by the extended period of submersion within sodium hydroxide. Other tests have been done at the lab with good results, which is why this experiment was set up. However, none of those artifacts were submerged for such a prolonged period. Because the butt of the stock turned out poorly and it would not be possible to reassemble the gun upon completion, it was decided to let the rest of the stock also air dry to confirm the lack of silicone bonds present. In an attempt to reestablish the silicone bonds and save the wood of the remaining four rifle stocks, they will proceed through the silicone oil process again, and those results will be discussed in a paper to come.

Figure 9. MGR 014 pre-conservation (left) and post-conservation (right) (Photos by S. Cox and R. Sasaki).

The stock of rifle MGR 014 pre-conservation measured 109.5 cm in length, which was taken to the end of the nose cap since the nose cap could not be removed. Three width measurements and three height measurements were taken at easily identifiable locations; the end of the butt, center of the lock, and just before the nose cap. These same locations were used on the other rifles when possible. The width of the butt measured 4.5 cm, the lock also measured 4.5 cm, and the area just before the nose cap measured 3.0 cm. The height of the butt measured 12.5 cm, the lock measured 5.0 cm, and the area just before the nose measured 2.5 cm. in the post-conservation stage it was impossible to get an accurate measurement of the rifle due to the manner in which it broke, however wood does not shrink longitudinally, so it is fairly safe to assume the length would have changed very little. The width measurements post-conservation were 3.3 cm at the butt, 4.5 cm at the lock, and 2.5 cm just before the nose cap. The height measurements post-conservation were 8.8 cm at the butt, 4.5 cm at the lock, and 2.1 cm just before the nose cap. The width measurements are deceptive. They appear as though nothing has significantly changed, when in fact the wood has shrunk and warped. The cross section at the lock now looks as though it is comprised of three pieces of wood instead of one, and the gaps between these warped pieces makes up a portion of the measurement. The width measurement at the nose is similarly deceptive. The nose cap is still attached to the stock, however the wood has curled in on itself. Had it not been attached to the nose cap, the wood would have curled to a greater extent. The height measurements show just how much the rifle shrank, which is similar to waterlogged wood allowed to air dry with no other conservation treatment.

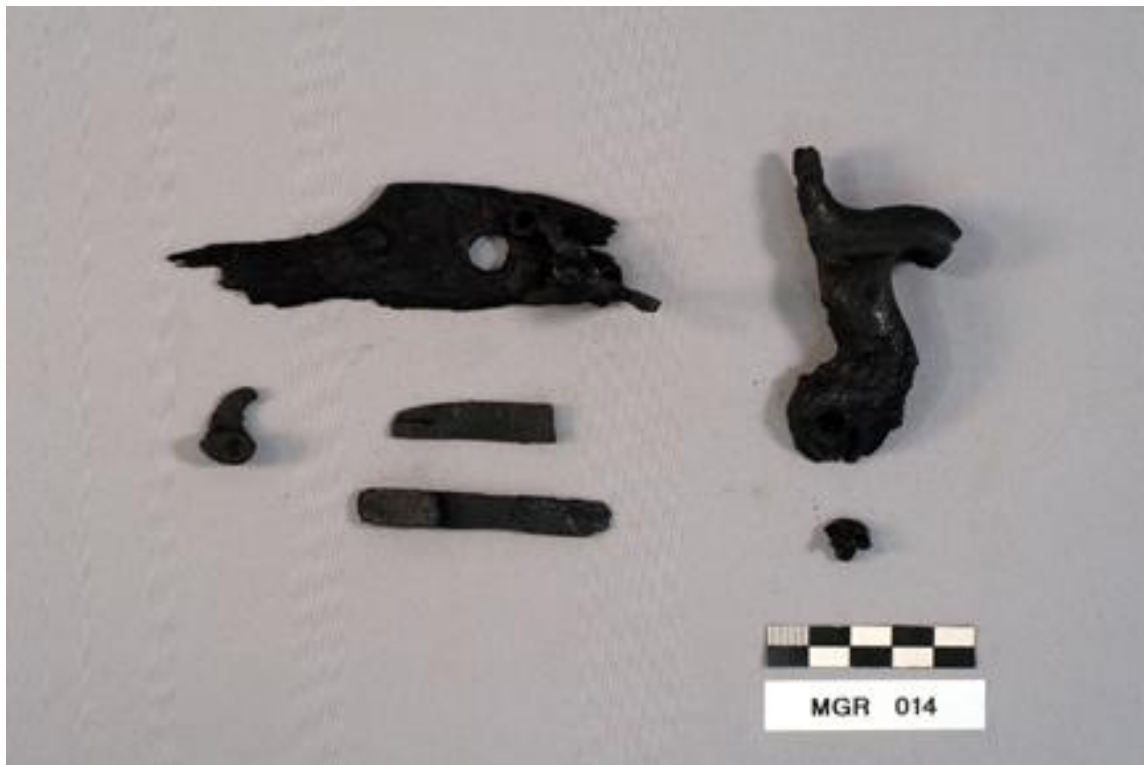
The iron from MGR 014 (figures 10 and 11) that survived the long submersion in saltwater included part of the barrel and ram rod, the hammer, the lock plate with the sear attached, the mainspring, the tumbler, and some less identifiable lock parts. The barrel is 52.0 cm in length, and tapers from 2.6 cm in diameter at the breech to 1.9 cm. The ramrod is 67.2 cm in length and approximately 0.6 cm in diameter. The hammer measures 7.6 cm in height, 3.6 cm in width across the head, and is 1.4 cm thick at the head. The lock plate measures 10.7 cm in length, 3.0 cm in height, and is 0.4 cm thick. This measurement does not include the sear. The main spring is 6.2 cm in length, 2.5 cm and 0.6 cm in height at each end, and is 0.3 cm thick. The tumbler is 1.8 cm tall, 1.2 cm wide, and 0.3 cm to 1.0 cm thick. Considering the condition of these components prior to conservation, they turned out quite well. The silicone oil process slowed down the removal of chlorides through ER, but did not stop the process. There were no identifiable maker's marks present prior to conservation, and due the degraded state of the iron, none were uncovered post-conservation.

Figure 10. MGR 014 lock plate, hammer, tumbler, mainspring (two pieces), and hammer screw (Photo by R. Sasaki).

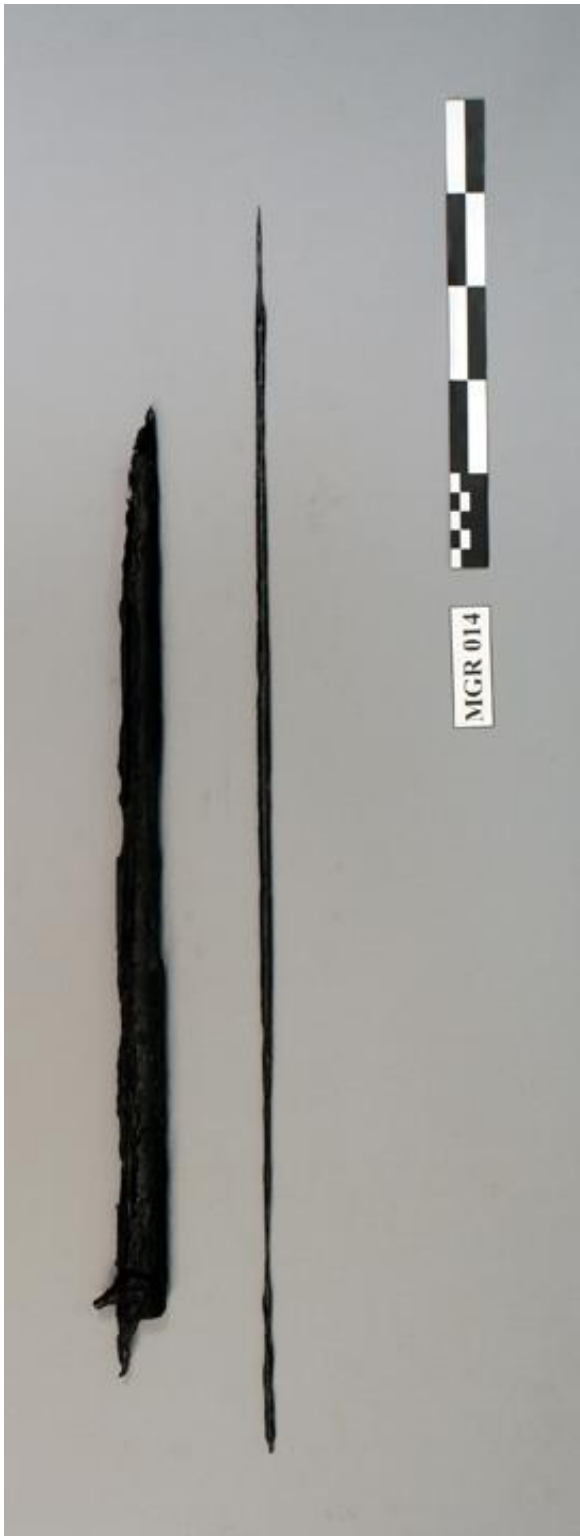
Figure 11. MGR 014 iron barrel and ramrod (Photo by R. Sasaki).

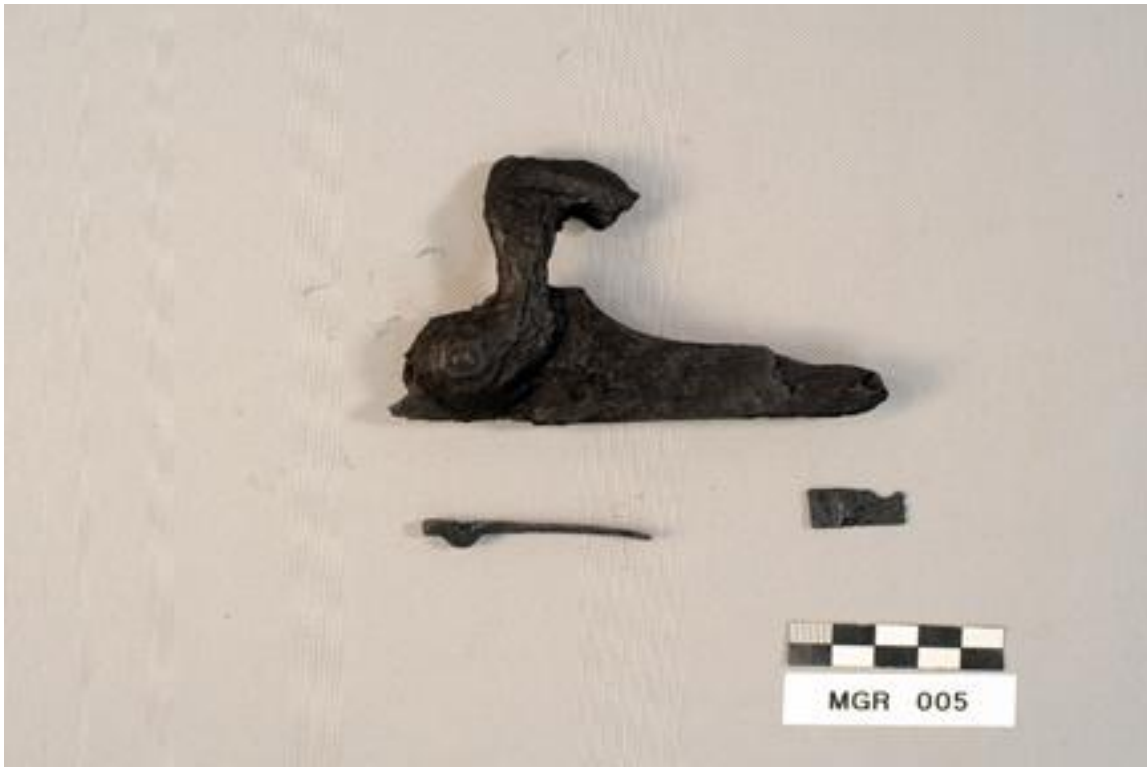
Considering the amount of iron present after 100 years in the ocean, the conservation turned out well. Many parts were still present, although none were complete. Surviving pieces of iron include the lock plate with attached hammer, two pieces of the barrel, the ramrod, and the ramrod spring (figures 14 and 15). The lock plate measures 11.3 cm long, 3.0 cm tall, and 0.35 cm thick. The word “TOWER” is stamped into the lock plate in front of the hammer, however, this word was not visible on any image. This is the only rifle with any remaining maker’s marks found on iron. The hammer measures 5.6 cm tall, 3.4 cm wide across the head, and 1.4 cm thick across the head. The main part of the barrel is 73.7 cm long and tapers from 2.6 cm to 1.9 cm in diameter. The small section of barrel measures 4.6 cm long, 1.6 cm wide, and 1.4 cm tall. Height is being measured on this piece instead of diameter because it has been flattened and no longer retains its original shape. The ramrod measures 85.4 cm long and is 0.6 cm in diameter. The ramrod spring is 5.3 cm long, 0.6 cm wide, and 0.2 cm to 0.3 cm thick.

Figure 15. MGR 005 lock plate with hammer, ramrod spring, and part of the mainspring (Photo by R. Sasaki).

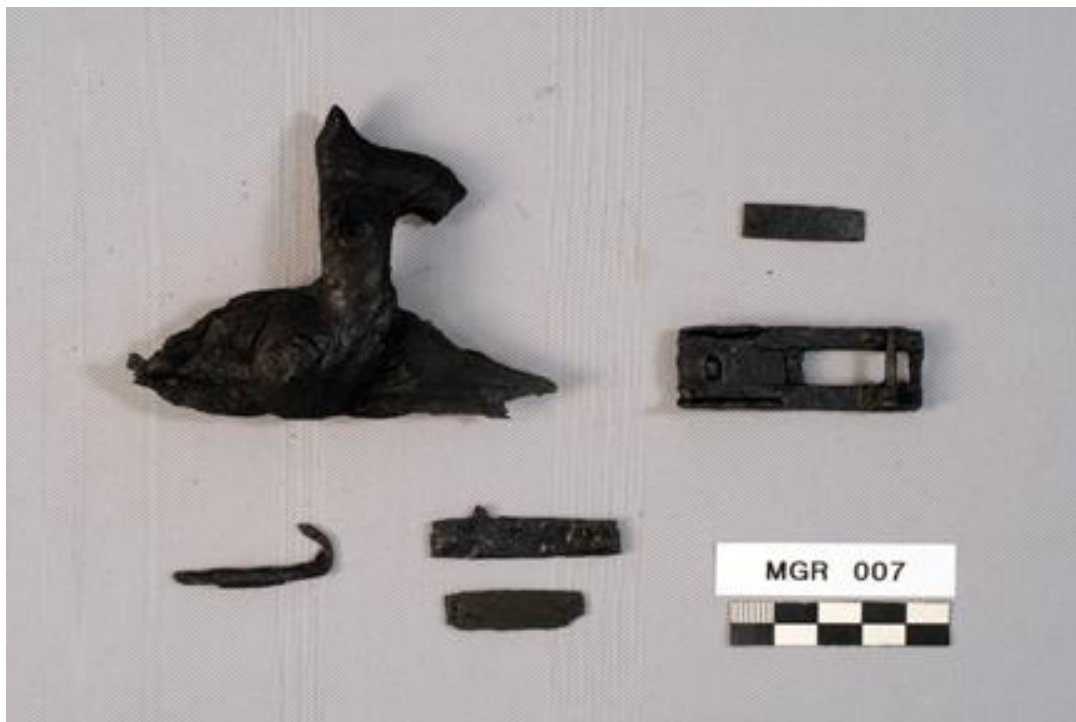
The surviving iron from MGR 007 includes the lock plate with hammer, tumbler, and bridal attached, barrel, ramrod, mainspring, swivel, and rear sight (figures 18 and 19). The lock plate measures 9.9 cm long, 2.9 cm tall, and 0.1 cm thick. The hammer measures 6.8 cm tall, 3.3 cm wide across the head, and 1.3 cm thick across the head. It is not possible to obtain diagnostic measurements from the corroded tumbler and bridal. The barrel measures 100.1 cm long and tapers from 2.6 cm to 1.8 cm in diameter. The ramrod measures 65.6 cm long and 0.3 cm to 0.6 cm in diameter. The mainspring is in two pieces and they measure 4.5 cm and 3.2 cm in length and they are 0.15 cm thick. The swivel measures 3.7 cm long, 1.4 cm tall, and has a diameter of 0.5 cm thick. The rear sight measures 5.6 cm in length, 1.8 cm in width, and 0.7 to 1.3 cm tall.

Figure 19. MGR 007 lock plate with attached hammer, rear sight (two pieces), swivel, and mainspring (two pieces) (Photo by R. Sasaki).

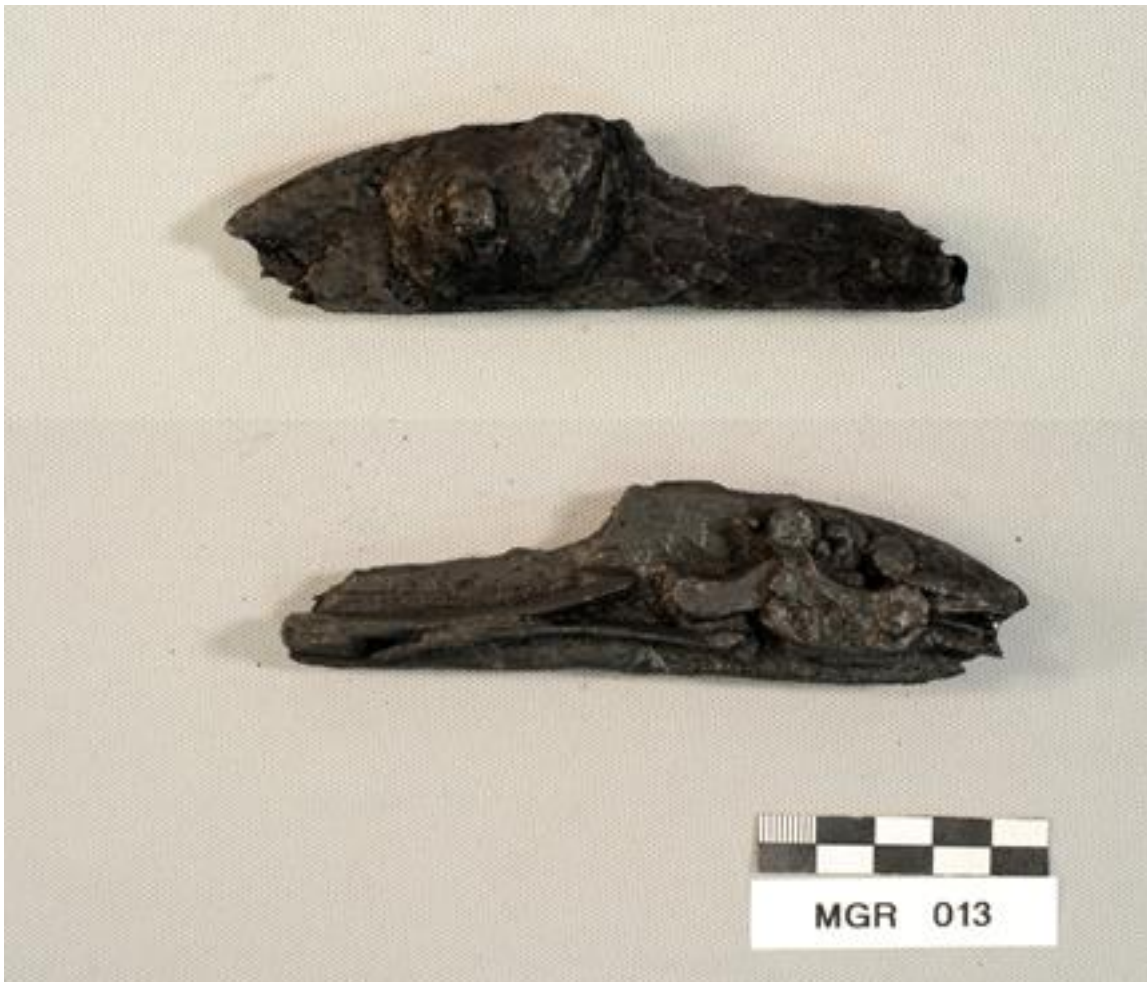
The iron that survived on MGR 013 includes a good portion of the lock plate with some attached parts, the barrel, and the ramrod (figures 22 and 23). The lock plate measures 12.3 cm in length, 3.1 cm in height, and is 0.2 cm thick. The bridal is too corroded to obtain any diagnostic measurements, and the stirrup and tumbler are obscured by the bridal. The barrel measures 91.0 cm long, and tapers from 2.85 cm to 1.8 cm in diameter. The ramrod is 71.2 cm long and has a diameter of 0.6 cm. The ramrod spring measures 3.0 cm in length, 0.6 cm in width, and is 0.2 cm thick.

Figure 23. MGR 013 lock plate with attached parts (Photo by R. Sasaki).

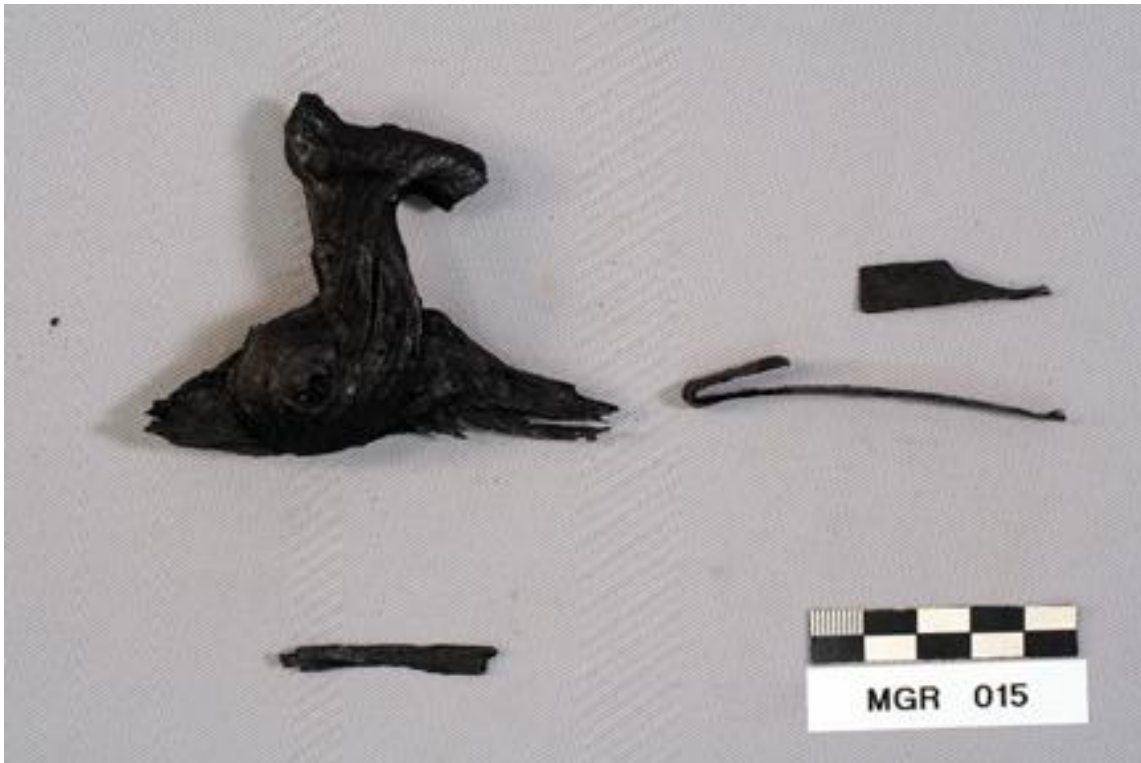
The iron that survived includes two pieces of the barrel, a small portion of the lock plate with the hammer, bridal, and tumbler attached, the ramrod, the ramrod spring, and three pieces of the mainspring (figures 26 and 27). The breech end of the barrel measures 27.1 cm in length and tapers from 2.7 cm to 2.5 cm in diameter. The forward section of the barrel measures 38 cm in length and tapers from 2.3 cm to 2.0 cm in diameter. However the end of the barrel is incomplete, so the barrel would have a smaller diameter at the nose. The lock plate measures 8.7 cm long, 2.3 cm tall, and 0.3 cm thick. The hammer measures 6.5 cm tall, 3.5 cm wide across the head, and 1.4 cm thick across the head. The tumbler and bridal are too heavily corroded to gather diagnostic measurements. The ramrod is 41.9 cm long and has a diameter of 0.5 cm. The ramrod spring measures 4.1 cm in length, 0.55 cm in width, and is 0.2 cm thick. The mainspring is in two pieces and they measure 7.1 cm and 3.6 cm in length, 0.5 in height at the intact end, and they are both 0.9 cm wide and 0.1 cm thick.

Figure 27. MGR 015 iron lock plate with hammer, mainspring (two pieces), and ramrod spring (Photo by R. Sasaki).
